Manhole Inspection Summary

Manhole # S47SS_002MH

Insp Date: 1/31/08 11:19 AM

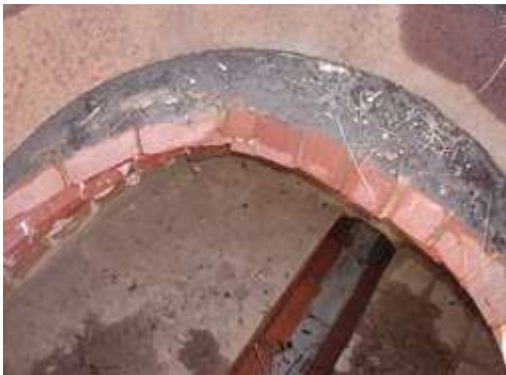
Defect 2

Frame Offset: **3** (in.)

Frame Offset

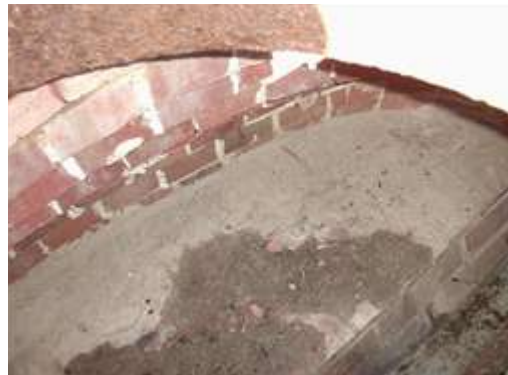
Defect 1

☒ **Cracked**

☒ **Leaks**

Frame Leaks

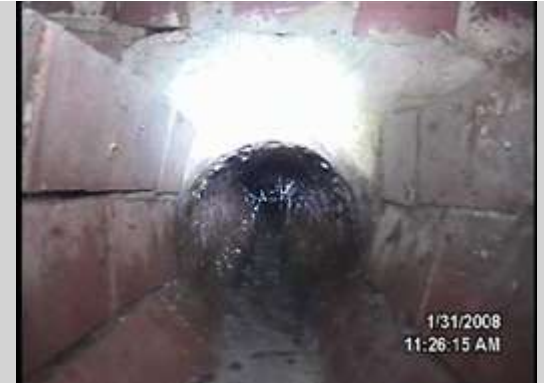
12 O'Clock Outflow

8 in. Circular Gravity Sewer
Pipe Out @ 12 O'Clock

Pipe Height: **8.4** (in.) Rod and Bar (Angled)
Pipe Material: **Clay** ☐ Pipe Lined
Invert Depth: **3.87** (ft.) Flow Characteristics: **None**
Deposits: ☒ None ☐ Mud ☐ Sludge ☐ Debris ☐ Grease
Silt Depth: (in.) Deposits Extent:
Infiltration: **None** Pipe Seal Cond: **Sound**

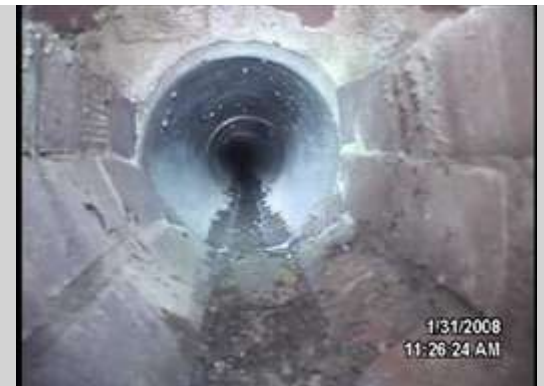
6 O'Clock Inflow

8 in. Circular Gravity Sewer
Pipe In @ 6 O'Clock

Pipe Height: **8.4** (in.) Rod and Bar (Angled)
Pipe Material: **Clay** ☐ Pipe Lined
Invert Depth: **3.38** (ft.) Flow Characteristics: **None**
Deposits: ☒ None ☐ Mud ☐ Sludge ☐ Debris ☐ Grease
Silt Depth: (in.) Deposits Extent:
Infiltration: **None** Pipe Seal Cond: **Sound**
